5 SPARK PLUG MISFIRING (1956 8-Cylinder Engines)

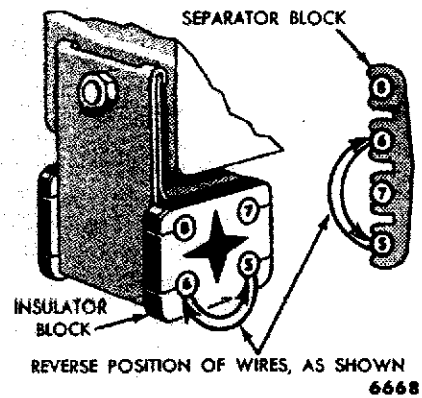
Fig. 4 - Ignition Wire Relocation
(Item 5)

Occasional spark plug misfiring in 1956 8-cylinder engines can be caused by induction firing between the No. 6 and No. 8 cylinder spark plug wires. This condition can be corrected as follows:

Reverse the positions of No. 5 and No. 6 wires in the left-hand harness insulating blocks and separator blocks as shown in Fig. 4. This will increase the distance between the No. 6 and No. 8 wires and eliminate the induction firing.
